APPENDIX H

**Phipps Ocean Park Borrow Area
Video Survey**

FINAL REPORT

March 2002

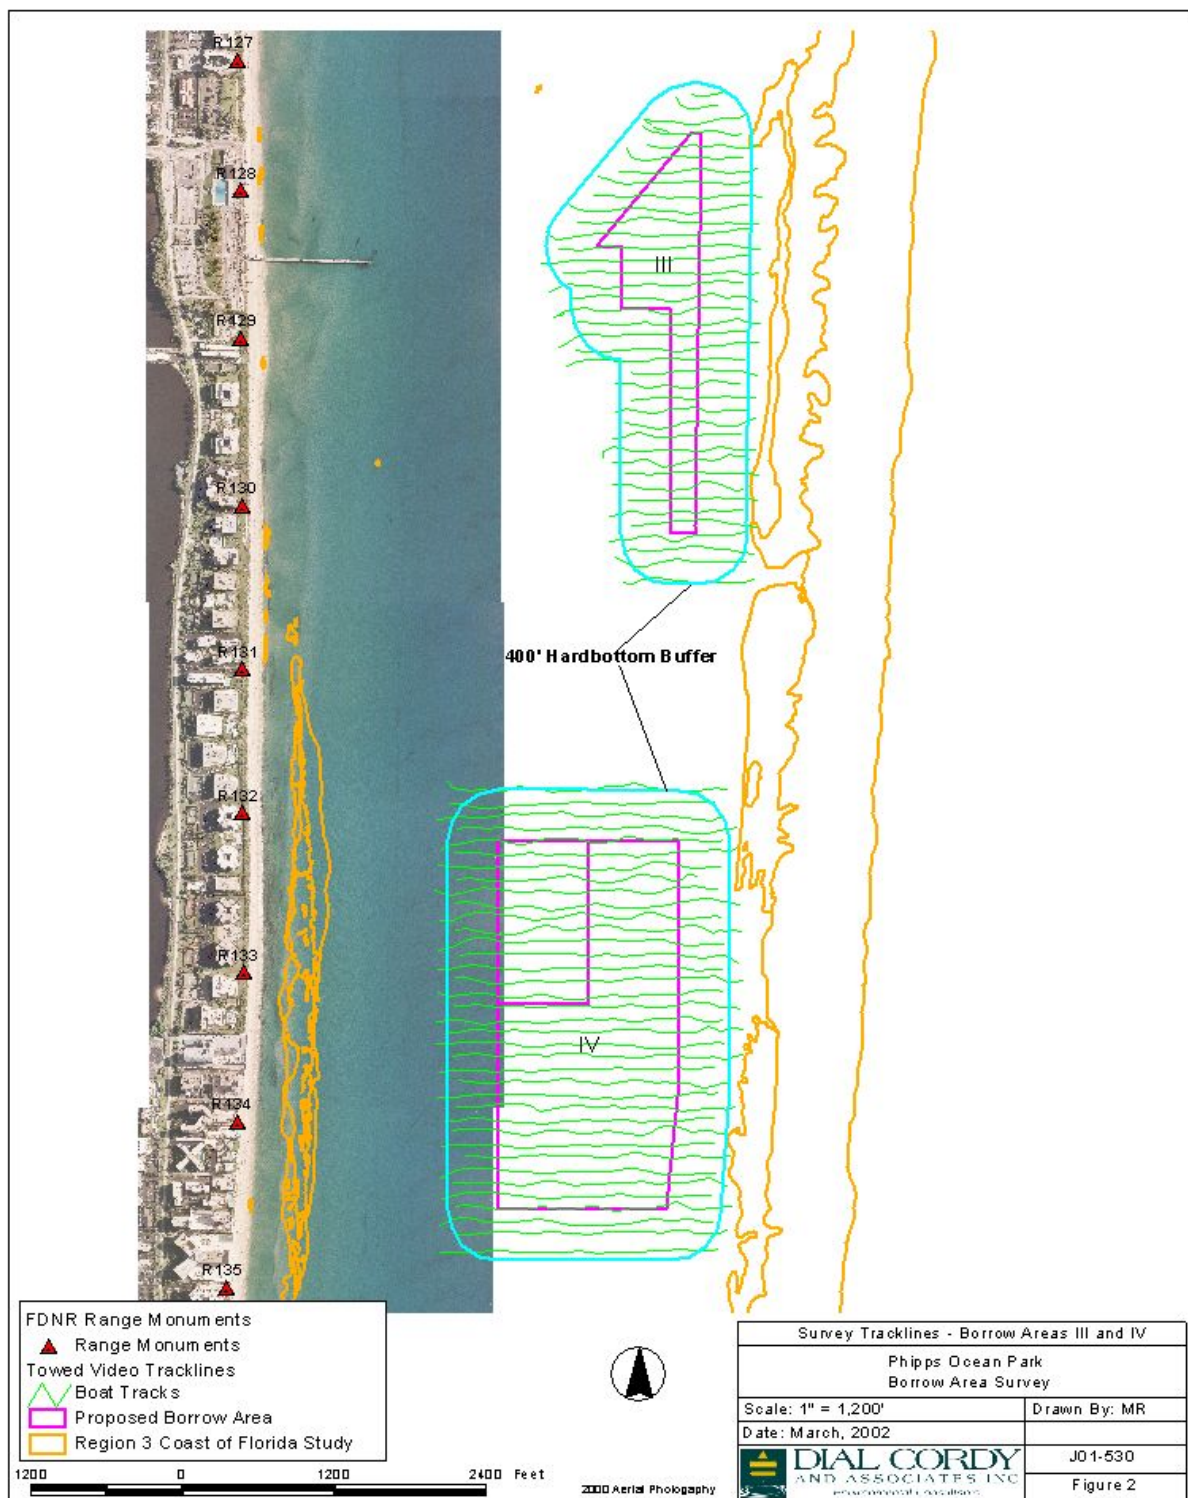
Figure 2 Survey Tracklines - Borrow Areas III and IV

To determine the extent of marine resources within the proposed borrow area, a towed video survey was conducted. This survey consisted of towing an underwater video camera in conjunction with a DGPS and video overlay of coordinates. In total, 76 transects were towed, spaced at 100-foot intervals across each borrow area (Figure 2). These transects included the proposed cut limits of the borrow area, as well as a 400-foot buffer around each borrow area to protect any marine resources found during preliminary surveys of the area. Hardbottom areas located within this 400-foot buffer area were mapped and characterized with diver surveys at the conclusion of the towed video survey. Video was then interpreted and a GIS map of the area delineating marine habitats was prepared.
